Manhole Inspection Summary

Manhole # S17W__004MH

Insp Date: **6/24/08 12:49 PM**

Location Address: **1614 sexton st**

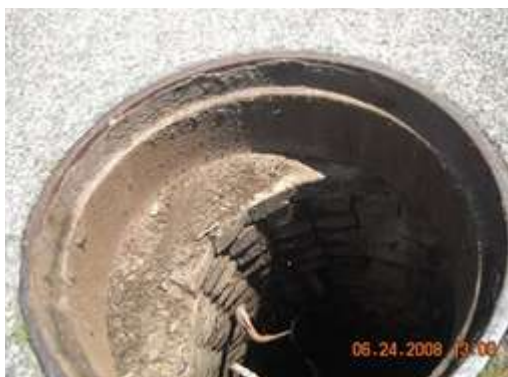
Misc

Manhole Type: **Inline** Location: **Roadway** Ground Conditions: **Dry**
☐ Prev. Rehab Weather: **Dry** Subject To Ponding: **Sheeting**

inflow evidence from sheeting

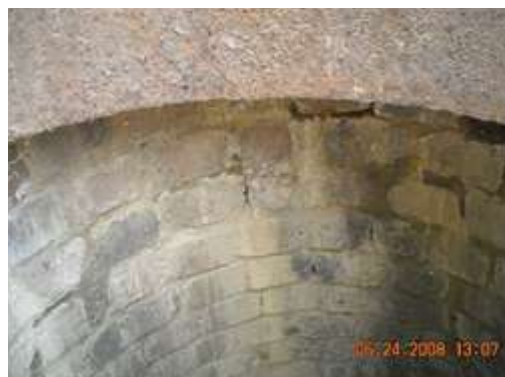
Defect 3

Infiltration: ☐ None ☒ **Joint** ☐ Cracks ☐ Mortar ☐ Roots ☐ Wall

infiltration @ corbel/frame joint

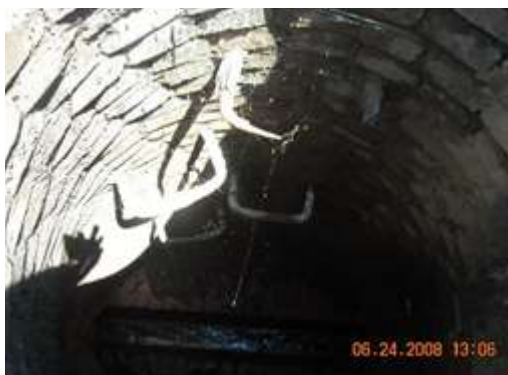
Defect 2

Steps Count: **3** Missing: **1** ☒ **Corroded**

corroded & missing steps

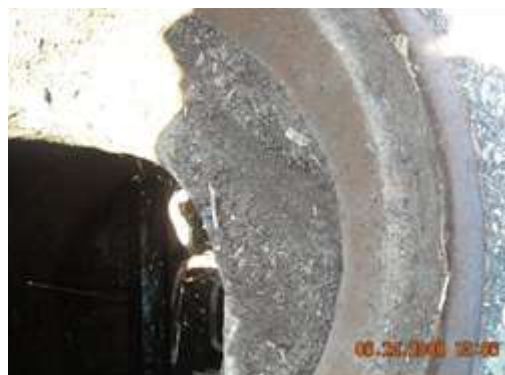
Defect 1

Frame Offset: **5** (in.) Condition: ☒ Sound ☐ Cracked ☐ Leaks

frame offset

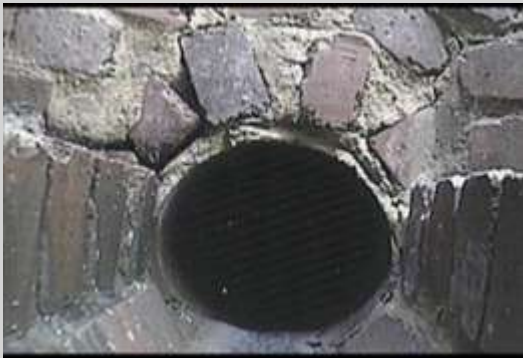
12 O'Clock Outflow

8 in. Circular Gravity Sewer
Pipe Out @ 12 O'Clock

Pipe Height: **8.4** (in.) Rod and Bar (Angled)
Pipe Material: **Clay** ☐ Pipe Lined
Invert Depth: **8.90** (ft.) Flow Characteristics: **Slow**
Deposits: ☒ None ☐ Mud ☐ Sludge ☐ Debris ☐ Grease
Silt Depth: **0** (in.) Deposits Extent:
Infiltration: **None** Pipe Seal Cond: **Sound**

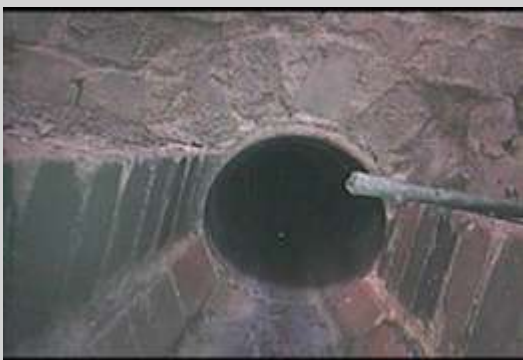
6 O'Clock Inflow

8 in. Circular Gravity Sewer
Pipe In @ 6 O'Clock

Pipe Height: **8.4** (in.) Rod and Bar (Angled)
Pipe Material: **Clay** ☐ Pipe Lined
Invert Depth: **8.81** (ft.) Flow Characteristics: **Slow**
Deposits: ☒ None ☐ Mud ☐ Sludge ☐ Debris ☐ Grease
Silt Depth: **0** (in.) Deposits Extent:
Infiltration: **None** Pipe Seal Cond: **Sound**

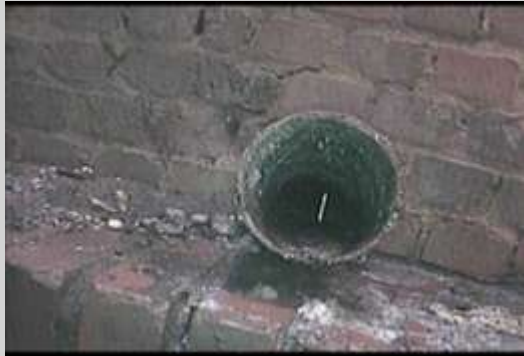
9 O'Clock Inflow

4 in. Circular Gravity Sewer

Pipe In @ 9 O'Clock

Connects To: **House connection / Service line**
